Property Inspection Report

**6959 211th Pl SW , Lynnwood,
WA, 98036**

Inspector: Joseph Pedersen

Date of Inspection: 2/9/2024

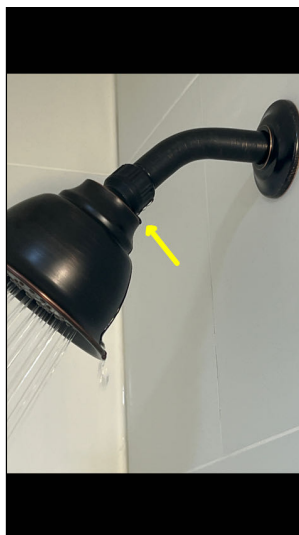
- **Shower head leaked needs to be tightened.**

Shower head leaks.

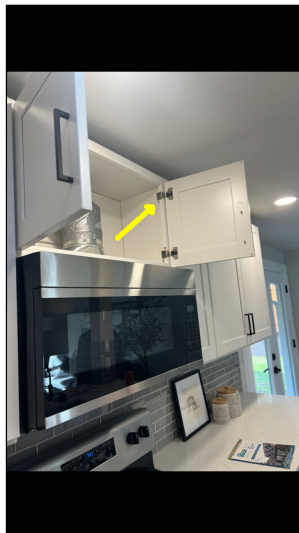
- Loose cabinet door.

Loose top hing just needs to be tightened.

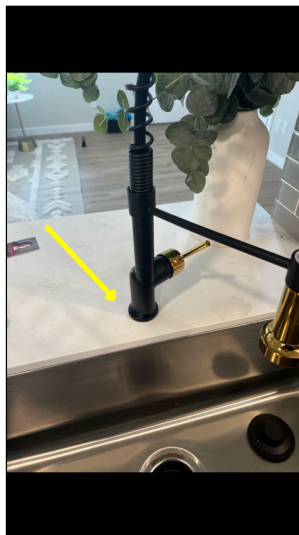
- 🔧 • **Faucet loose at base.**

Faucet loose at base.

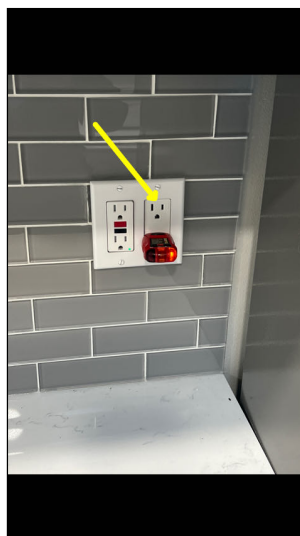
- **Outlet not GFCI protected.**

Outlet not GFCI protected.

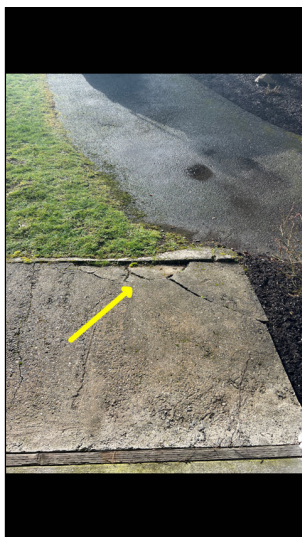
- Front apron of garage is cracked. Could be a trip hazard.
- Apron by service door of the garage is covered in moss and is considered a slip hazard.

Cracked apron in front of garage.

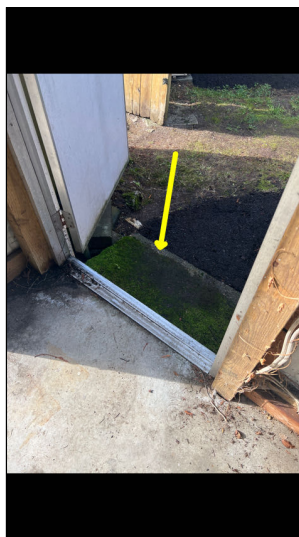
Moss covered apron by service door.

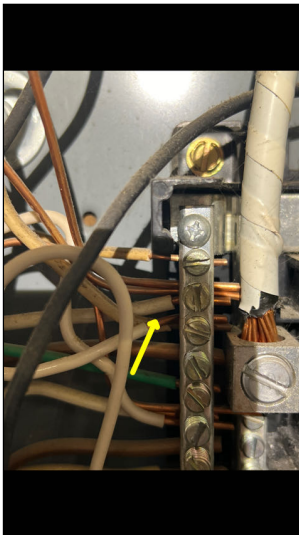
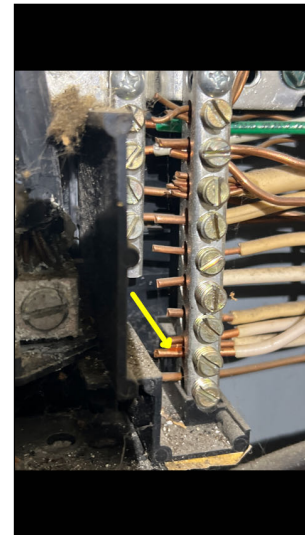
• **Double tapped inside panel box (more than one electrical conductor attached). This is not standard practice, and may cause overheating or even an electrical fire. Recommend evaluation by an electrician. Double tapping and lugging can create hot spots on breakers and neutral bars because they are not tightened to the correct torque--especially if two different size conductors are used. Because the hot [black] and neutral [white] wires are both current carrying conductors, the chance is then greater for potential hot spots. If the **double tap** or lug becomes loose, it begins to arc. As it arcs it builds up carbon. Carbon is then resistance and with more carbon buildup the more difficult it is for the conductor to make contact, thus increasing the current. The end result can be the breaker tripping because of the loose connection [current exceeding the rating of the breaker], or signs of overheating such as discolored wires, melted wires, etc, or even fire.**

Double taped.

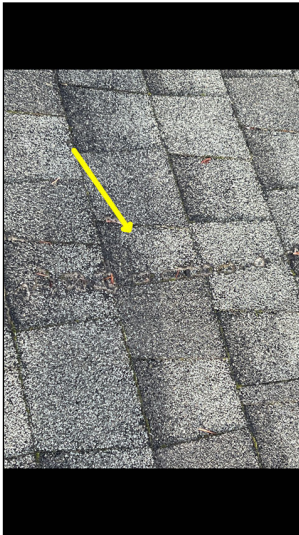
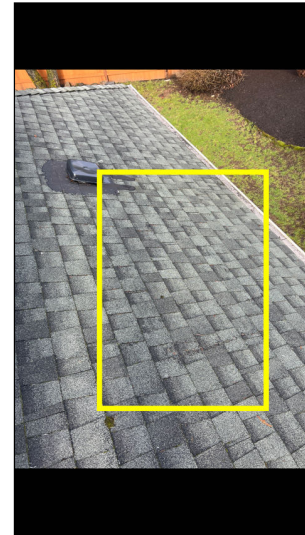
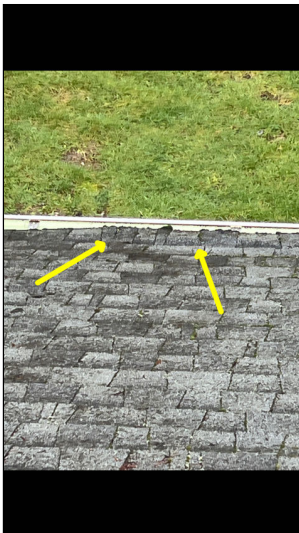
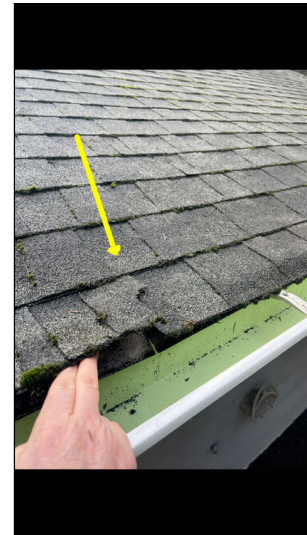
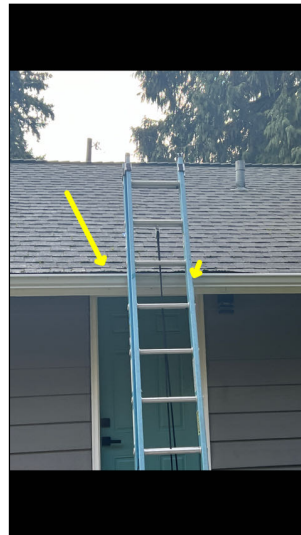
Damaged shingles.

Area of shingle damage.

Curling shingles at the low edge of the roof.

Broken shingle on edge of roof.

Area of damaged shingles.

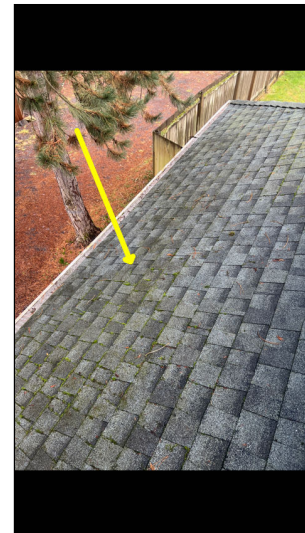
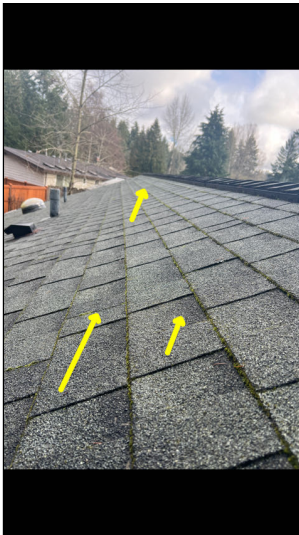
- Moss on roof. This can lead to the premature failure of the roof and subsequent leaks. Recommend treating moss during its growing season (wet months) with a moss killer. For information on various moss treatment products and their pros and cons, visit <http://bryophytes.science.oregonstate.edu/page24.htm>.
- Some damage to the shingles on the north side of house.

Moss on roof.

Moss on roof

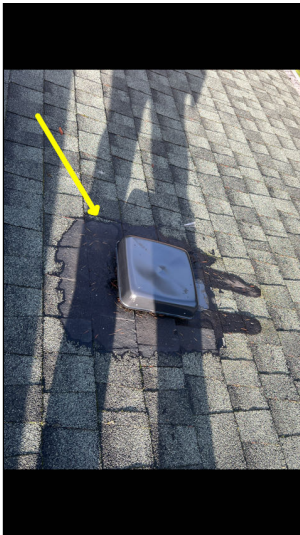
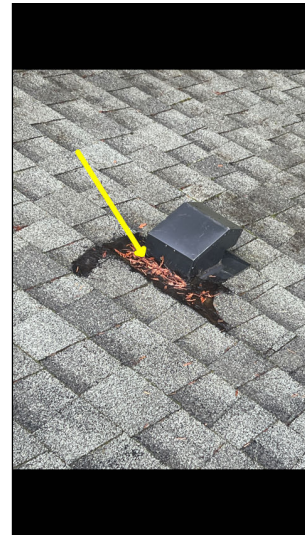
Poor repair job.

Another poor repair made on roof flashing.

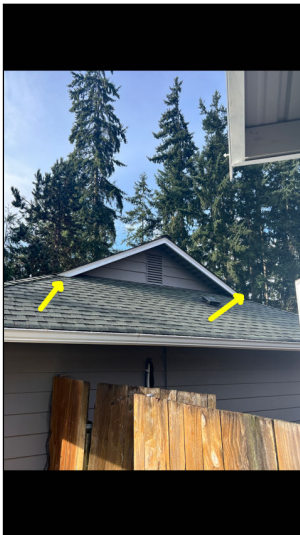
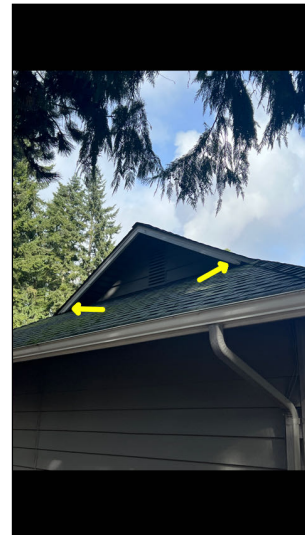
- no clearance of fascia board to roof- wood touching roof is rotting.
- Tar around roof vent used as repair is not acceptable.

Trim touching roof edge.

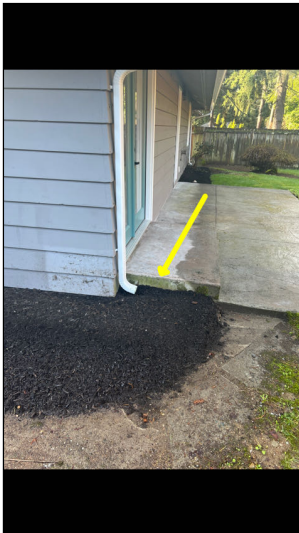
- Extensions / Splash blocks missing or insufficient: Install to divert water away from the foundation.

Recommend splash Block under downspout.

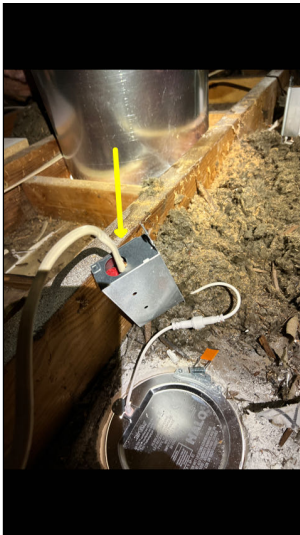
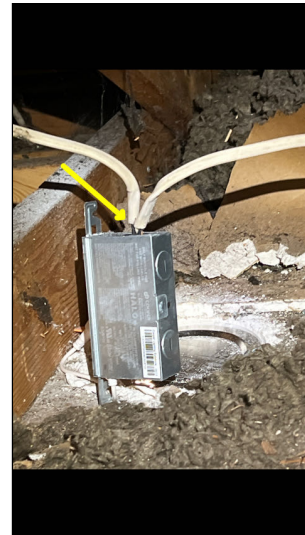
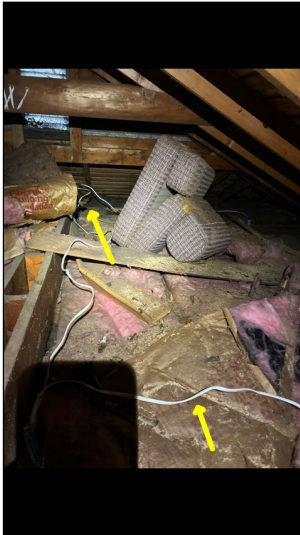
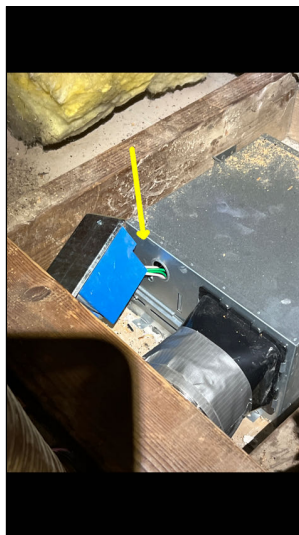
- A number of the ceiling lights do not have electrical connections to the box. This holds the wire in place and keeps the box from getting debris inside.
- Wires in the attic are not secured properly need to be secured.

Wire not clamped to box.

Wire not clamped into box.

Loose wires

Electrical for exhaust fan and bathroom is not properly secured.

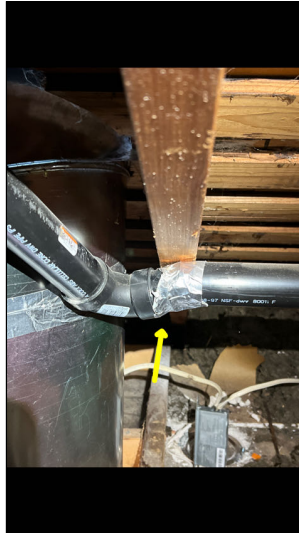
- Vent line, fastened by duct tape.

Poor connection in vent line. (Should be glued)

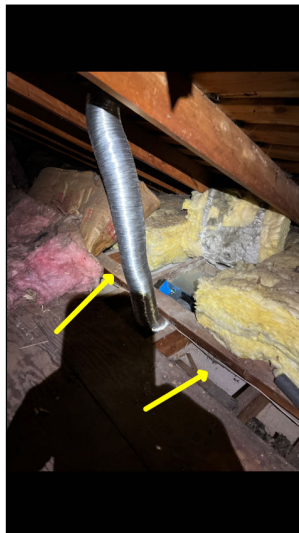
Depth: Insulation averages 3 to 4 inches. Recommend installing more.

Areas an attic or sparsely insulated.

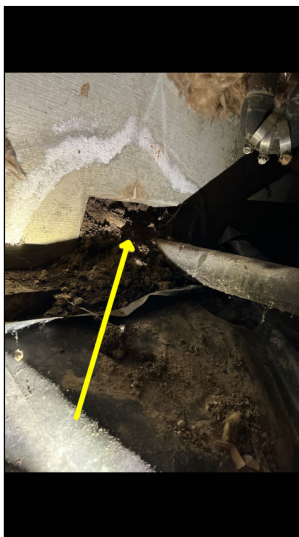
- 🌐 Cast iron waste and vent pipe noted.
- **Recommend sealing foundation where waste line leaves the building.**

Recommend sealing the foundation where plumbing exists to prevent rodents from entering the home.

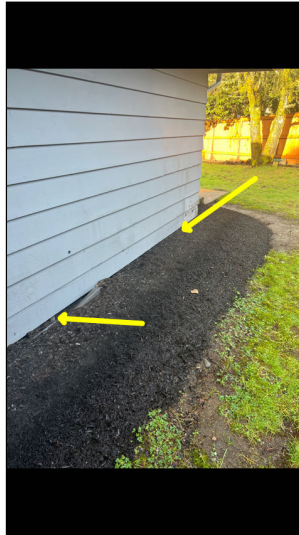
- Siding to Soil contact or proximity. This may provide entrance of moisture or insects to siding. Recommend grading soil so there is at least 6" of space (where practical) between the siding and the soil below and checking for any damaged trim and siding materials.

Mulch is too high on side of the house, and in contact with the siding it is also blocking, the venting for the crawlspace should be removed or lowered.

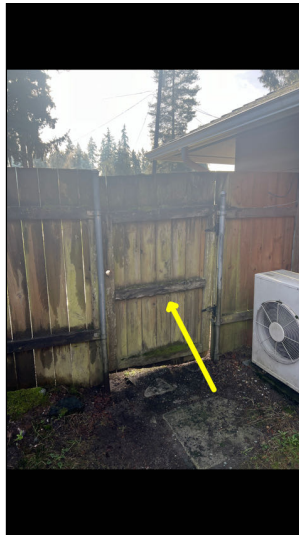
- Gate opens poorly needs to be repaired.

Poorly functioning gate.

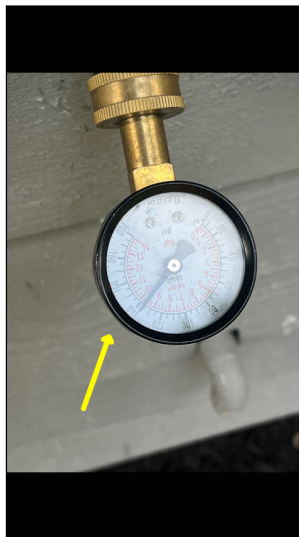
High water pressure at 135 psi. Recommended pressure is 80 psi.

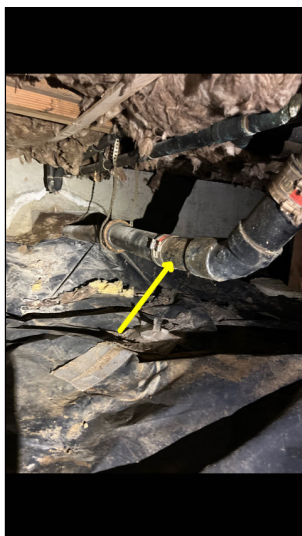
Negative grade on waste line.

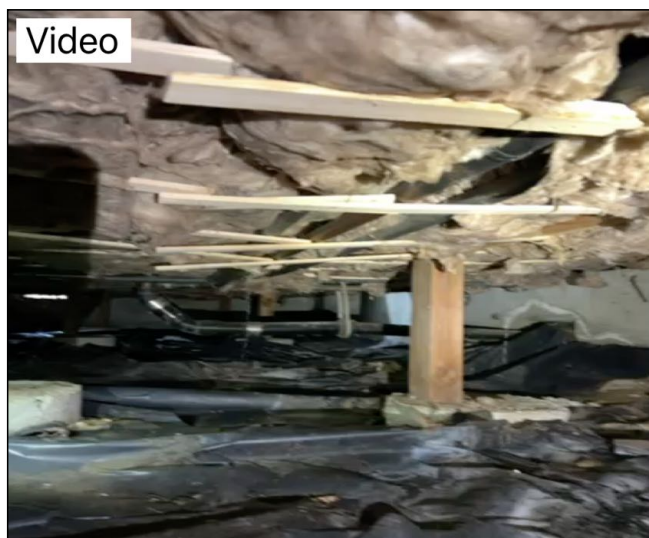
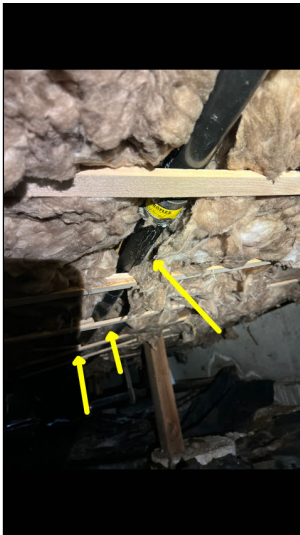
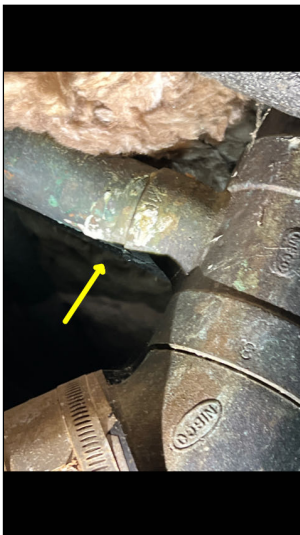
Active leaking from kitchen sink, drain line.

Waistline for kitchen sink leaks in several spots needs to be replaced.

Leak from kitchen sink that ties into waistline.

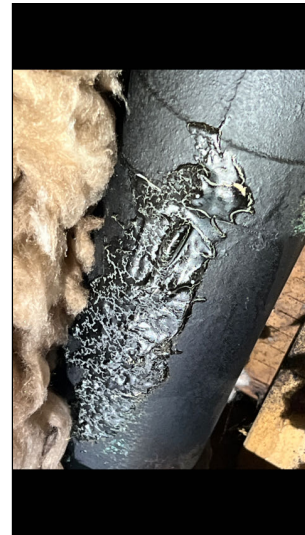
Questionable repair drain line from toilet.

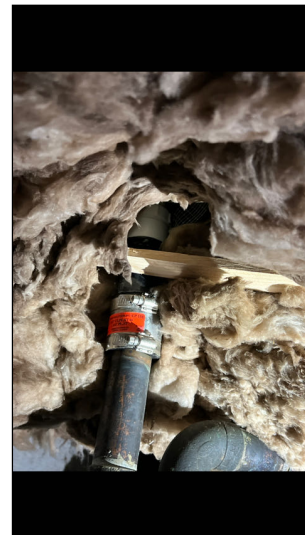
Questionable repair made to bathtub drain line.

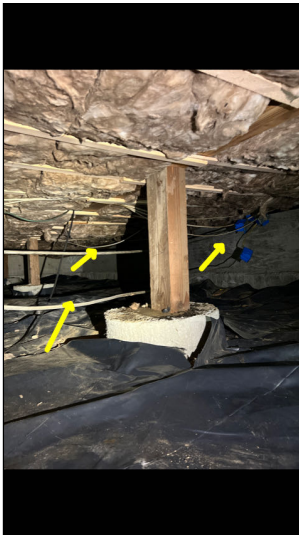
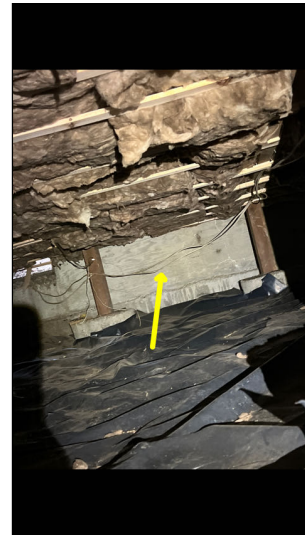
- Some loose wiring in crawlspace needs to be fastened to joist.

Loose wires.

Loose wires
